60-63 Chevy Truck  
Left Side

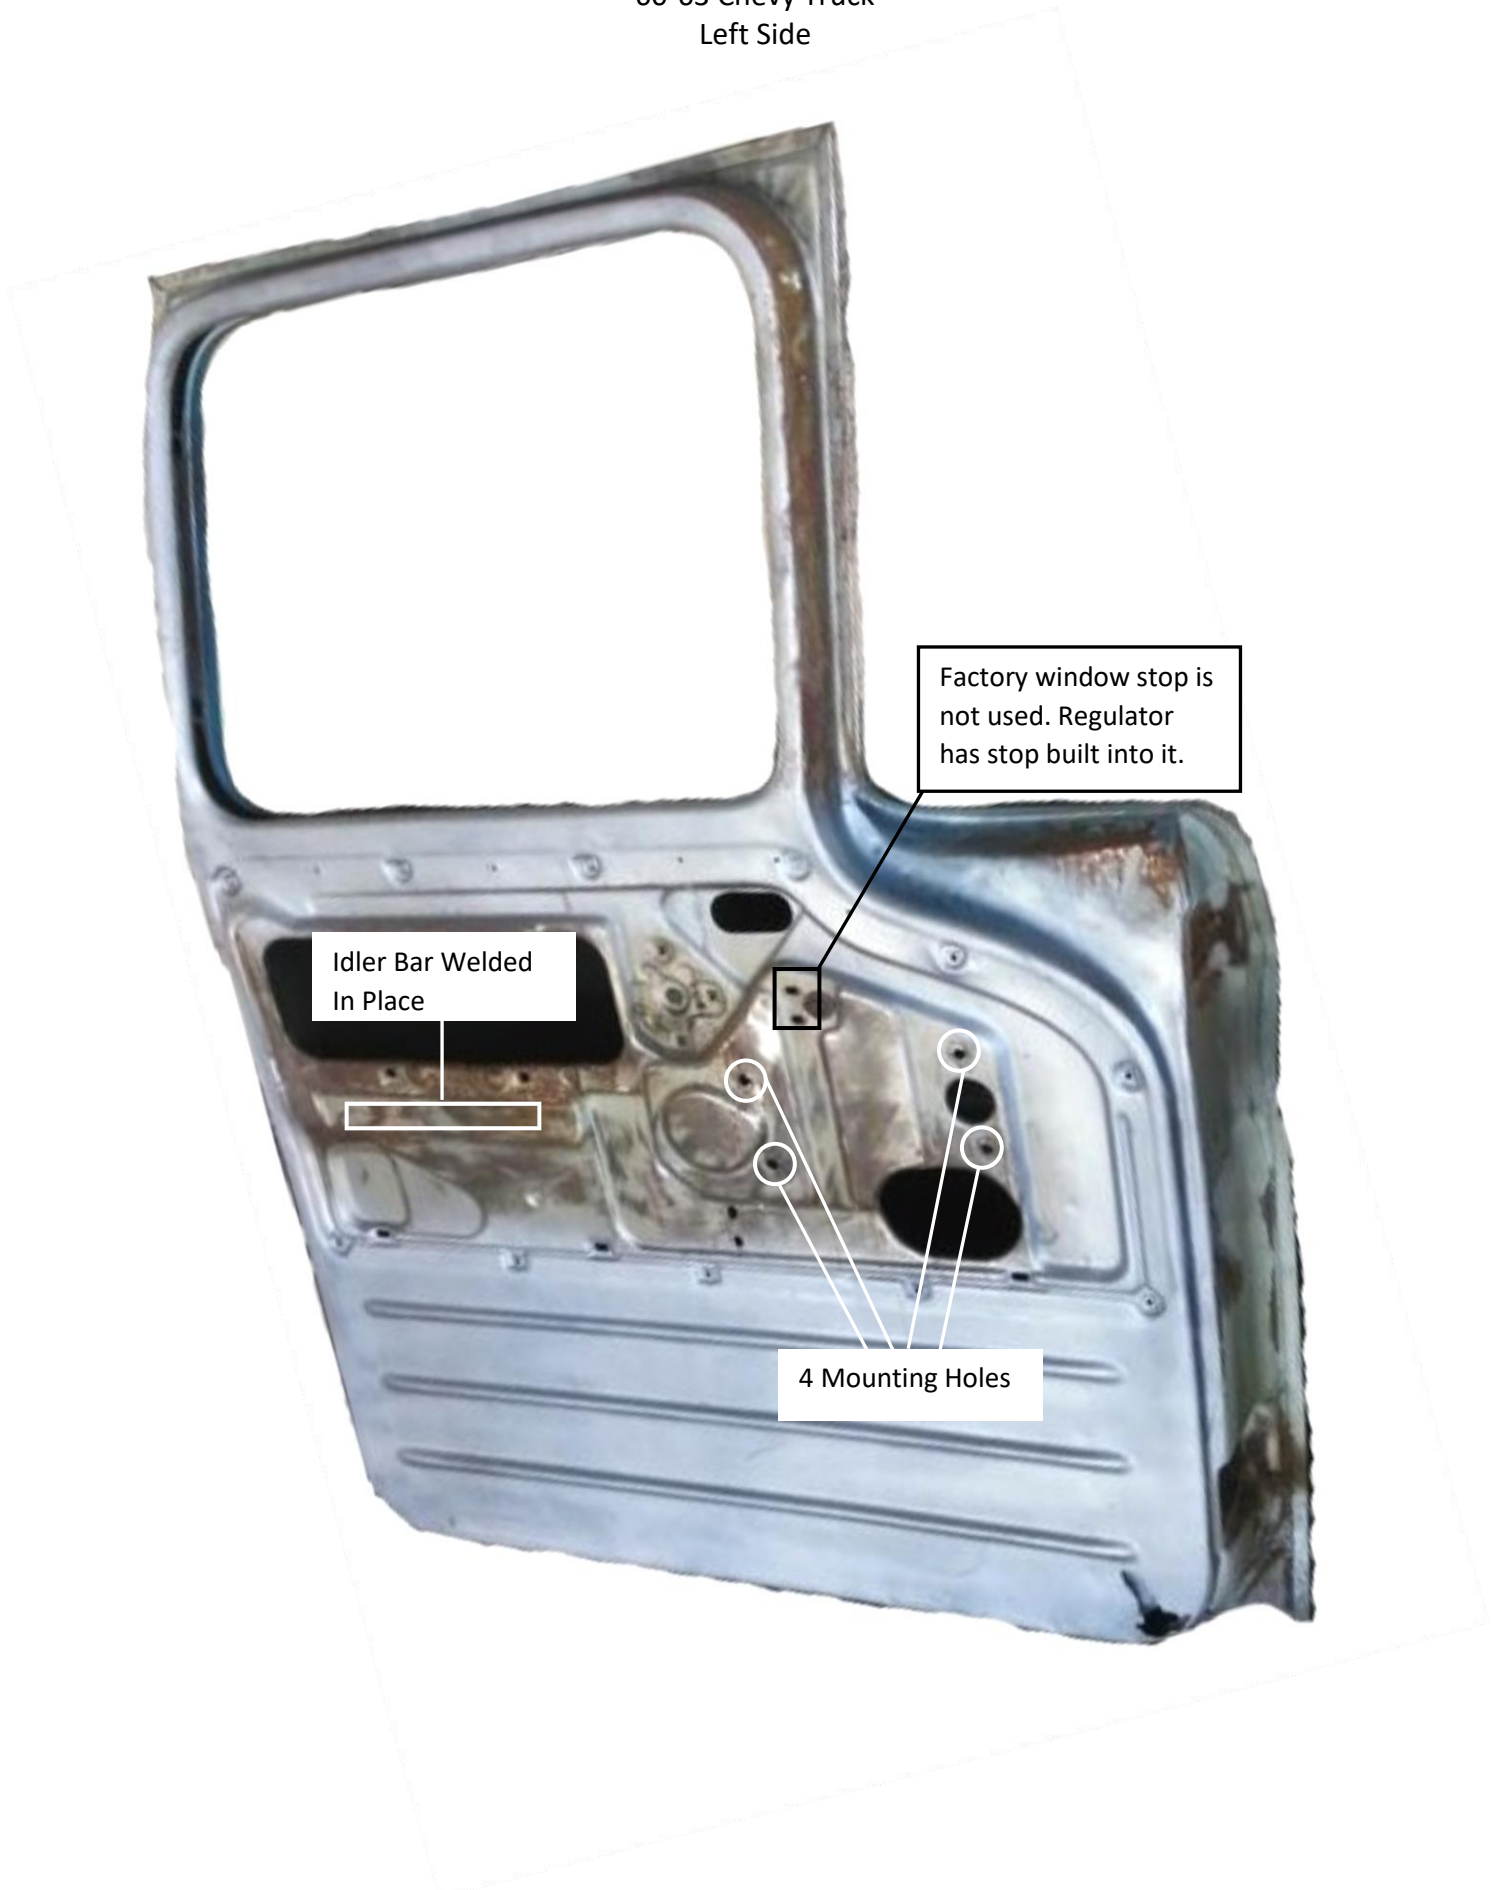
Factory window stop is not used. Regulator has stop built into it.

Idler Bar Welded In Place

4 Mounting Holes
