73-79 Ford Truck Left Side

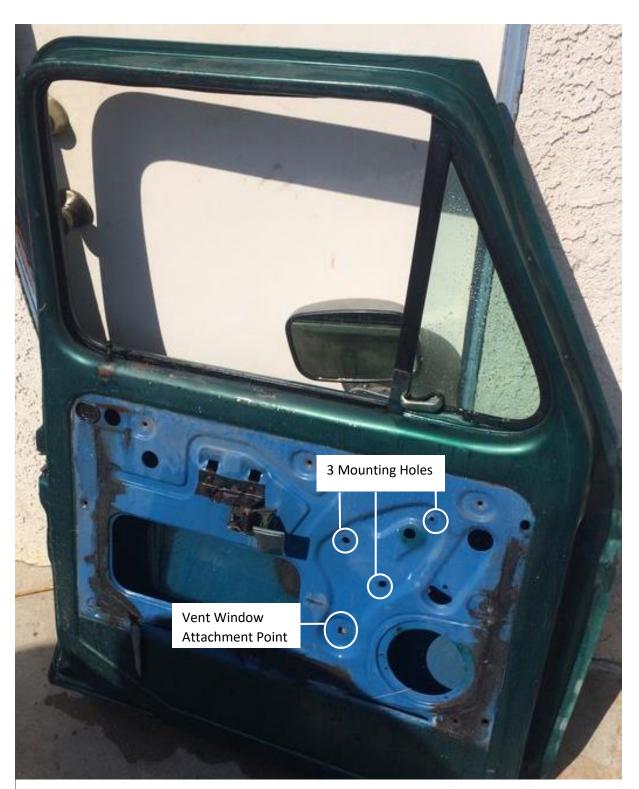
^{*}Stop is on regulator.

^{*}If using after-market speakers, they could interfere with the gear on regulator. If this happens, speaker will need to be shimmed out.
